Two Hot Plate Incidents- July and August 2017

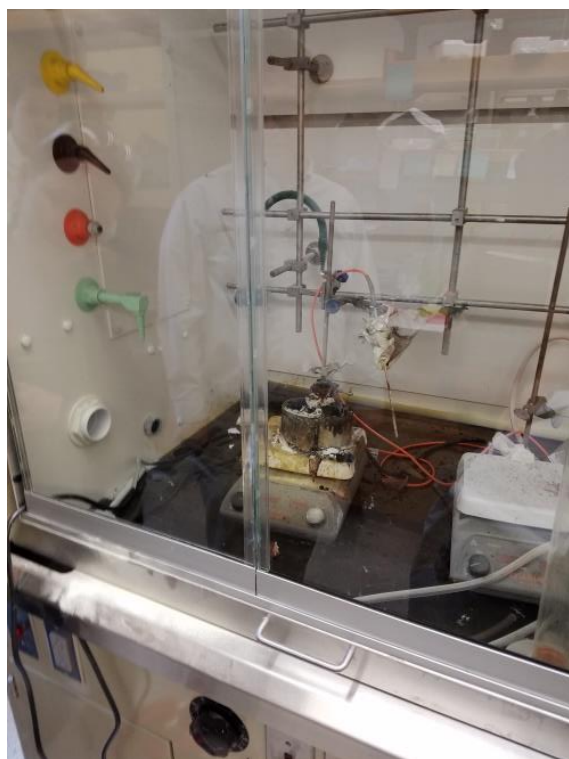
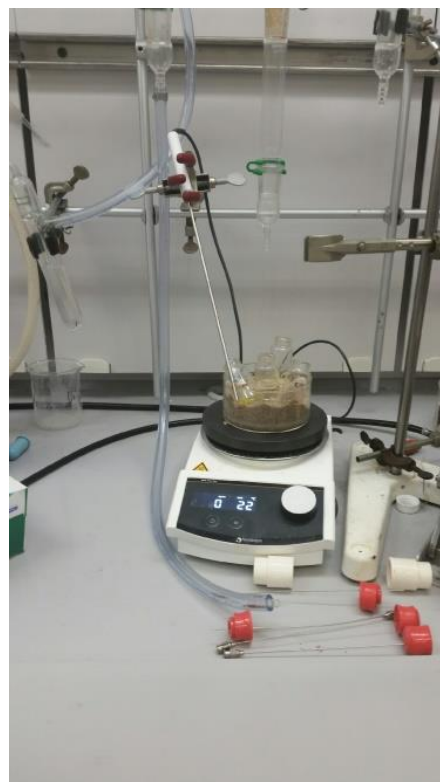
Photos

In July, a lab was following a well-established procedure at a scale (10g) that had been completed numerous times in a Teflon capped pressure vessel. The researcher placed the reaction in a silicon oil bath behind a blast shield, closed the fume hood's sash, and wrote their emergency contact and reaction information on the sash before heading to a group meeting. The temperature of the silicon oil bath exceeded the 120°C the hot plate was set to. The pressure vessel cap burst, the flammable vapors escaped, and a fire ignited. The lab members that were around were not comfortable using an extinguisher, so they evacuated and a more experienced lab member was able to extinguish the fire.

In August, a different lab was polymerizing styrene in 4 separate reaction vials each at a 5g scale. They had the reactions under nitrogen through a Schlenk line. The lab set up the reaction in a sand bath and the temperature of the hot plate was set to 80°C. The researcher closed the hood and went to the office while it was heating up. Lab members heard a loud pop and saw that the rubber septas on the reaction vials had been dislodged and polymer on the top of the hood's baffles. The other lab members alerted the researcher who had set up the reaction and he noted the hot plate's temperature was reading >110°C.

In both incidents the cause of the hot plates overheating was human error. There are numerous documented events where hot plates have malfunctioned and overheated, however we do not suspect that to be the case in either of these. In the July fire, the lab identified that the wrong temperature probe was placed in the silicon oil bath, as two identical hot plates with temperature probes were adjacent to each other in an otherwise uncluttered fume hood.

In August, the lab had placed the temperature probe inside a vial filled with silicon oil inside the sand bath. It was determined that by the time the silicon oil reached the 80°C the hot plate was set to the sand bath was around 140°C. The stored heat in the sand then transferred to the reaction vials until equilibrium between the sand and reactions was reached at a much higher temperature than the 80°C the hot plate was set to.

- When the possibility of wires or tubes getting mixed up and crossed use colored tape or other easily identifiable methods to distinguish between items.
- Always watch the initial heating of hot plates.
- Provide emergency contact information and reaction conditions anytime a reaction is going to be unattended.
- Take your time and double check the different components of the hot plate to ensure everything is in proper working condition.
